Re-fracture of Distal Radius and Hardware Repair in the Setting of Trauma.

To appear in: *Medical Student Research Journal*

Keywords: Volar locking plate-distal radius fracture-open reduction-internal fixation

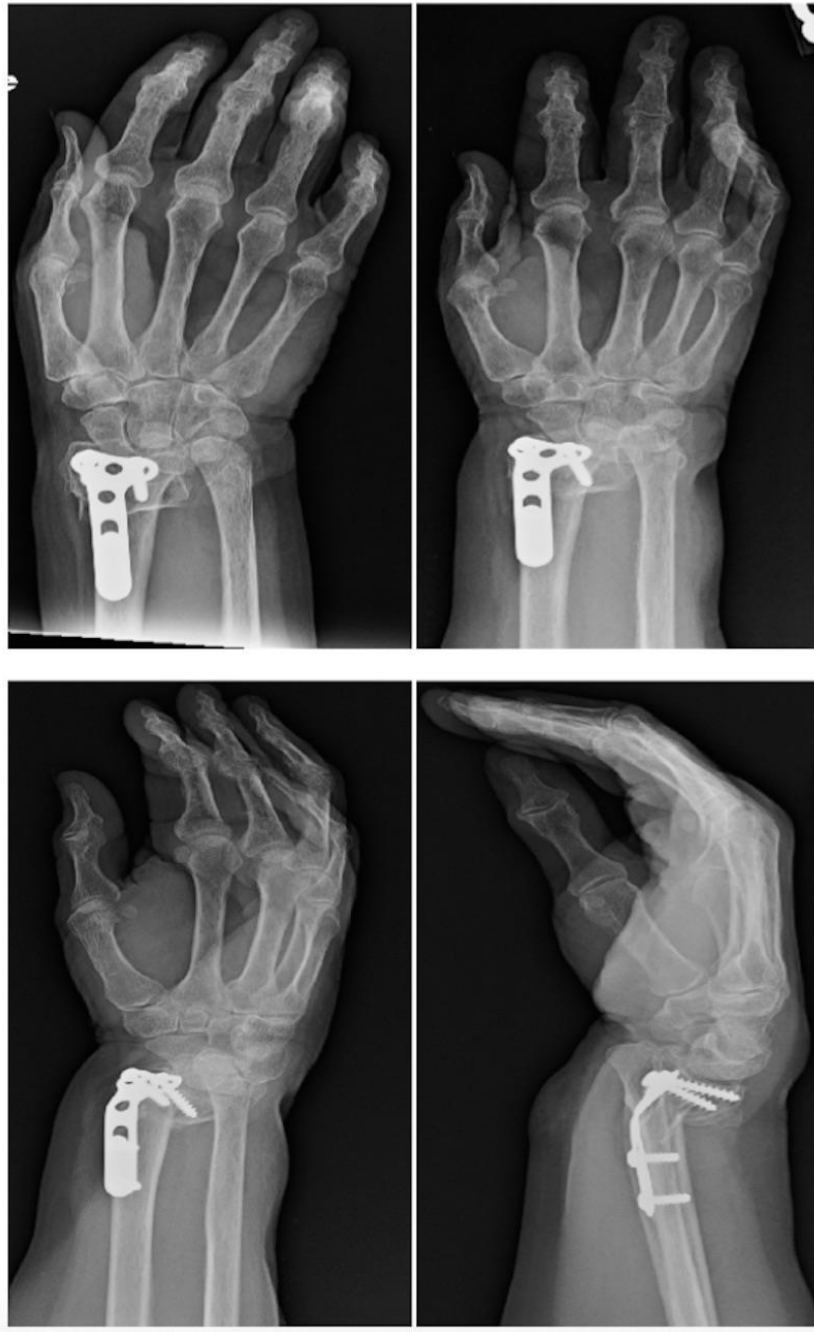
A seventy-three year-old female with a previous history of an open reduction and internal fixation of a right distal radius fracture via a four-hole T plate three years prior was brought to the hospital following a motor vehicle collision. Her injuries included a grade four splenic laceration with active extravasation, closed head injury, and right radius and ulna fracture. X-rays showed the volar plate was angulated and still affixed to the distal radius. The angulation resulted in abnormal volar displacement of the radiocarpal joint relative to the distal ulna with a dorsal articular tilt of forty-six degrees (Figure 1). She was taken emergently for splenic artery embolization.

Figure 1: Right hand X-rays prior to operative management showing deformed hardware and displaced distal radius fracture.

Post Trauma day-three, the patient was taken to the operating room for removal of deformed hardware and to perform a new open reduction and internal fixation. A longitudinal incision was made in the previous superficial scar with the standard volar Henry approach. Previous areas of screw placement had some ossification, so a rongeur was used to smooth out the areas and help facilitate placement of a new plate. Open reduction was performed with traction along the fingers in the radial direction and slight flexion and extension evaluated by fluoroscopy (Figure 2). Internal fixation was performed with a volar locking plate. Reduction maintenance and violation of the articular surfaces was verified, and placement of two additional screws in the radius shaft was performed with conformational fluoroscopy (Figure 3). Articular alignment was restored to a neutral volar tilt. The wound was irrigated, approximated, and closed. The patient was discharged and scheduled for follow-up with an orthopedic surgeon closer to home.

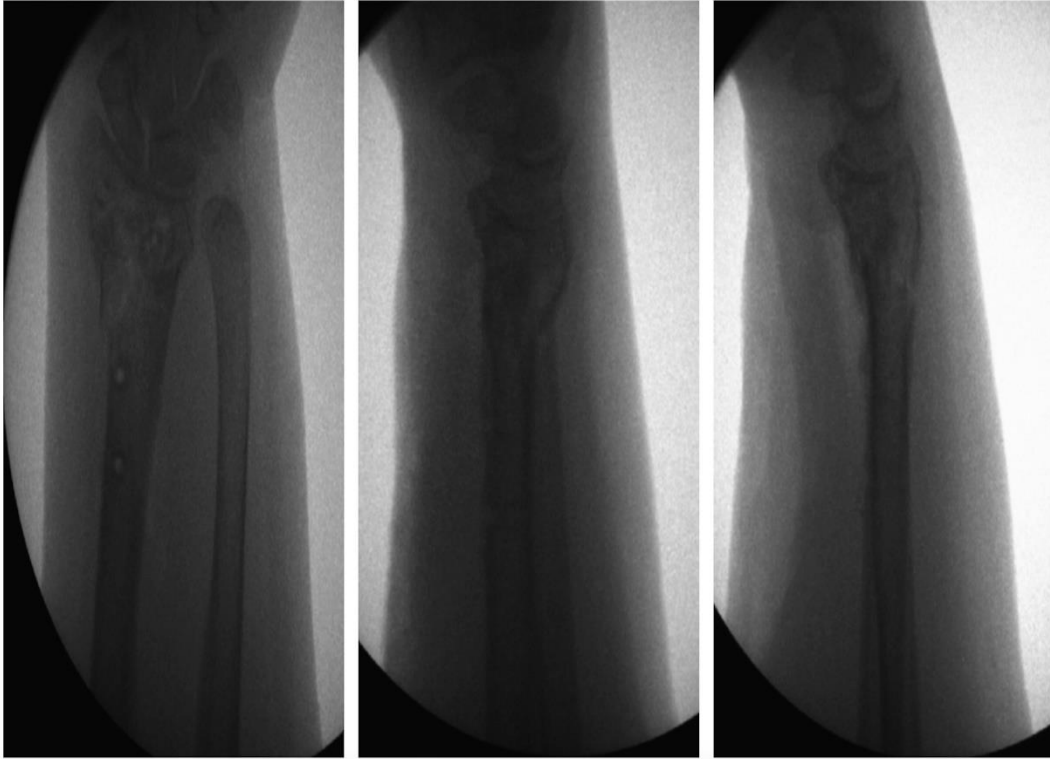
Figure 2: Intraoperative fluoroscopy imaging of right radius showing removal of previous hardware and visualization of screw holes with open reduction of the distal radius.

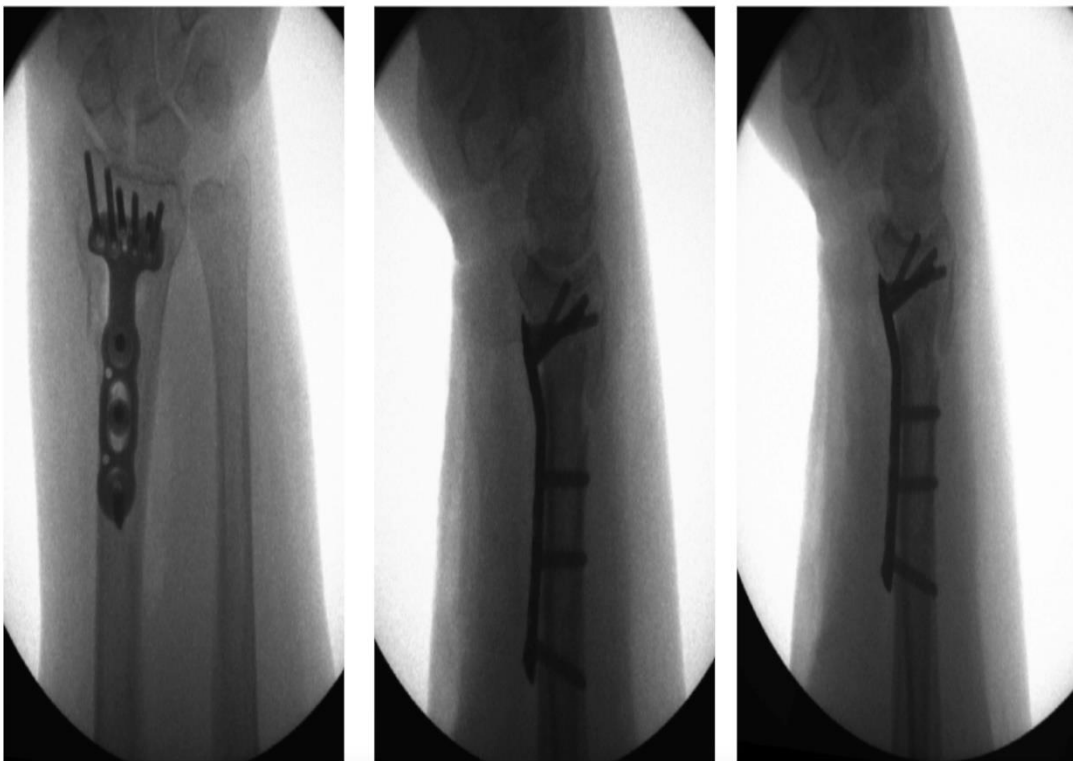
Figure 3: Intraoperative fluoroscopy showing placement of volar locking-plate.

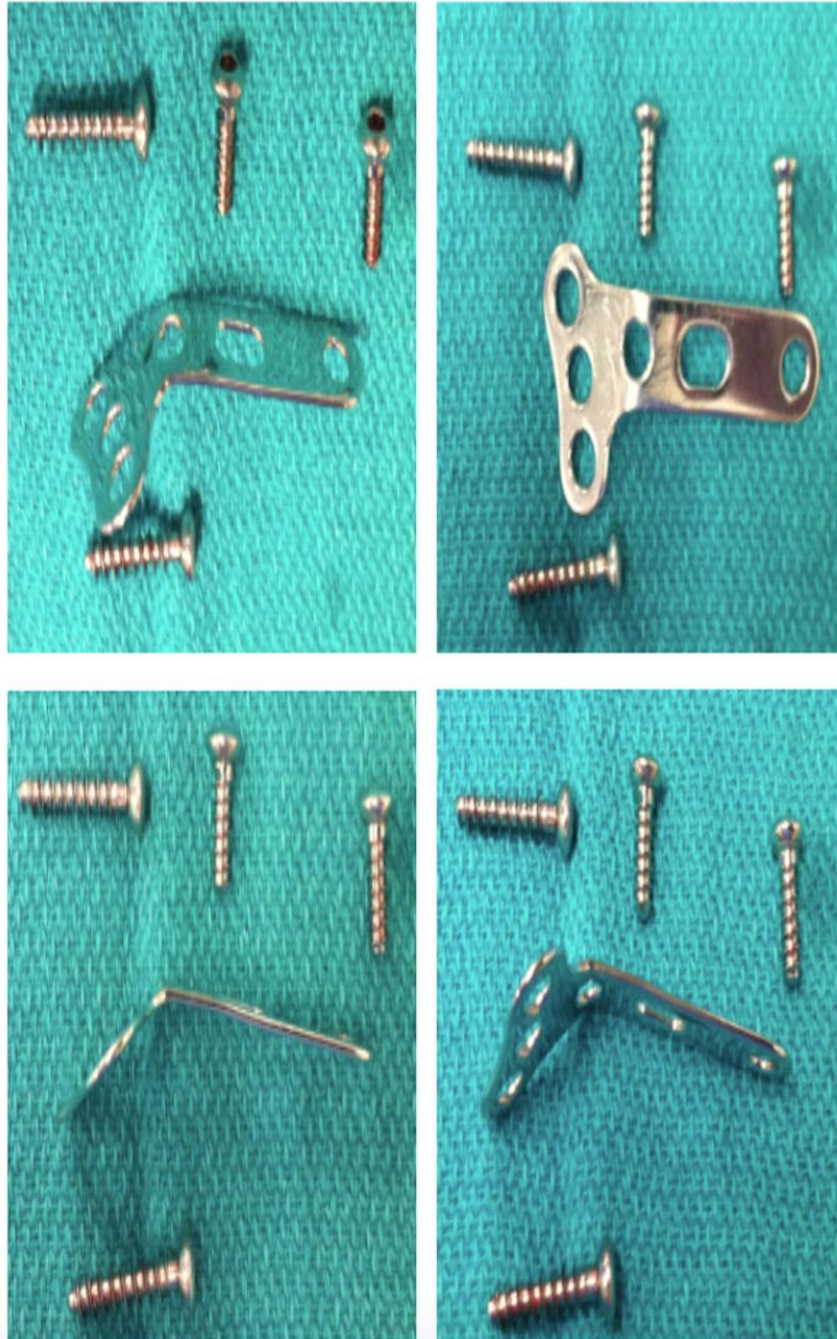
previous surgeon may have contributed to the failure as the plate was thin, and not a volar locking plate design, which contributes to a less stable repair in the elderly (Figure 4). Fortunately, the patient had an uncomplicated recovery. She was discharged and referred to a hand surgeon close to home for continued follow-up.

Figure 4: Ex vivo: removal of previous deformed volar plate and screws.
